# Development of Key Technologies for Transitioning of Direct Digital Manufacturing for Repair and Remanufacturing of High Value DoD Components

R. P. Martukanitz and F. Lia

Applied Research Laboratory Pennsylvania State University P.O. Box 30, State College, PA, 16804

Army Aviation and Missile Research Development and Engineering Center

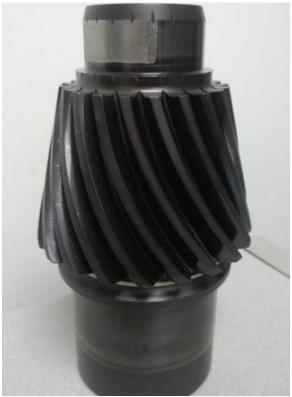
Figure 32 – Input pinion for AH64 identified by CCAD as a Critical Parts Demand item DDM repair.

The Input Pinion (PN: 7-211310021, NSN: 1615-01-163-4573), shown in Figure 32, is a gear in the main transmission for AH64 Apache System. CCAD has identified this part as a Critical Parts Demand Item. The proposed repair would be to apply DDM to repair corrosion and micro-wear pitting at bearing journal and lands. Material and part repair testing at bearing contact/ working surface would be required to approve this Non-Critical Safety Item (CSI). DDM represents an alternative repair to chromium electroplating at the seal journal to increase repair damage tolerance limits beyond current repair process limits. Material and part repair testing at bearing contact/working surface would be required or remanufactured by DDM. The Fedlog parts cost is \$3,566/ea., and potential savings of \$1,212/ea., or \$64,273 for the 53 ea. In SAFR has been estimated. Implementation would also provide critical parts support relief and reduced scrap by developing, qualifying, and authorizing a repair using DDM for an area of the gear that no other repair process can achieve.

The Input Bevel Pinion Gear is composed of Alloy AMS 6265, which is designed for carburization. Various degrees of ware were observed on the bearing surface. The component represents a carburized surface that was left intact and was solvent cleaned prior to laser deposition.

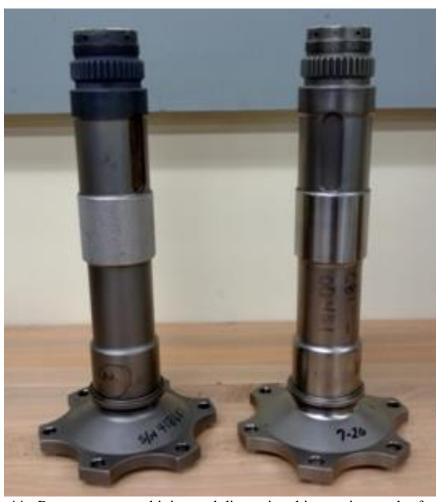
Figure 41 – Radiographic-based tomography of cooler fan shaft.

Figure 42 - Radiographic-based tomography of cooler fan shaft.

Figure 43 - Radiographic-based tomography of cooler fan shaft.

Figure 44 - Post-process machining and dimensional inspection cooler fan shaft.

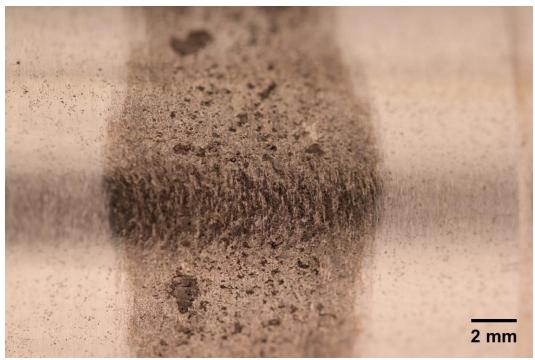
Figure 60 – RCF test results showing scuffing surface on the SS 431/20 TiC.

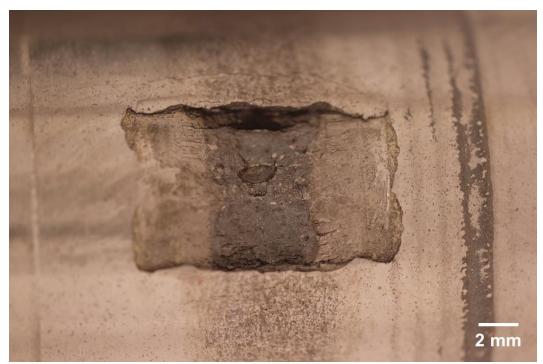
Figure 62 – RCF test results showing surface pitting on the SS 431/20 TiC specimen.
